May 6, 2005

**Re: 2004 Long-Term Operations and Maintenance Annual Report (Soil Remedy)
South Cavalcade Superfund Site – Concrete Cap**

2004 South Cavalcade Long-Term
O&M Annual Report

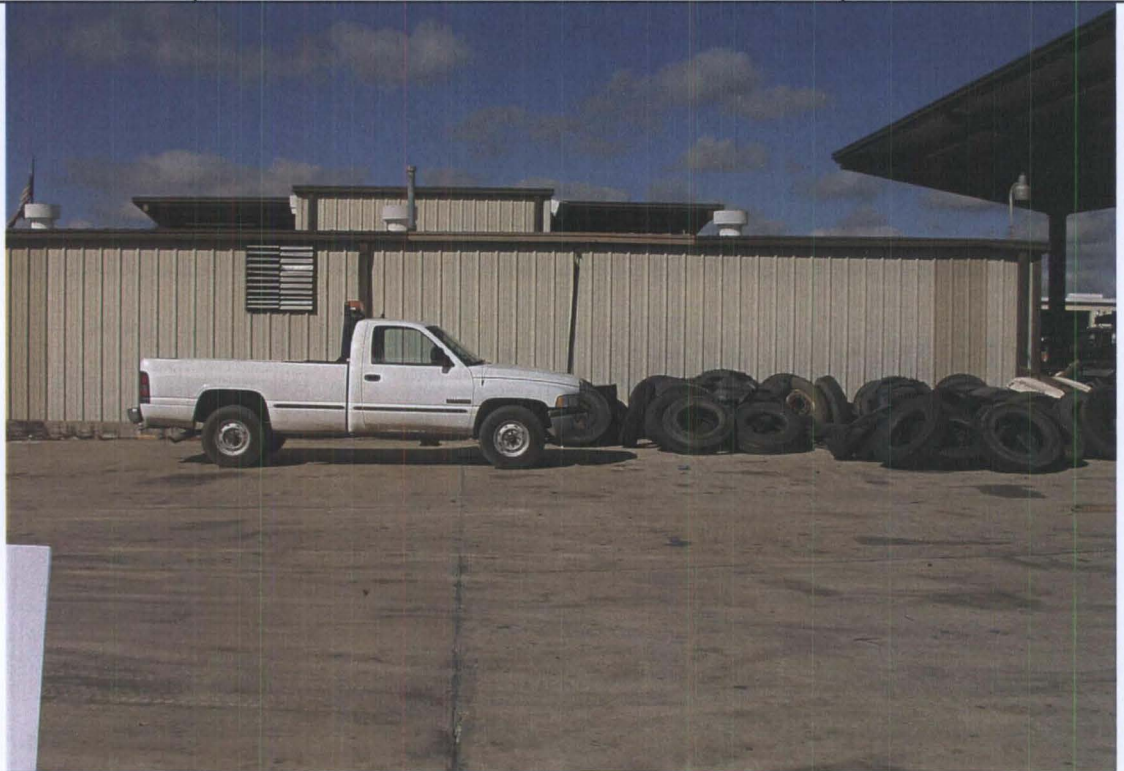
1

Photo shows on-site tire shop and typical condition of cap pavement and joint system. In basin 4 of the southeast area at the approximate location of cap and pavement.

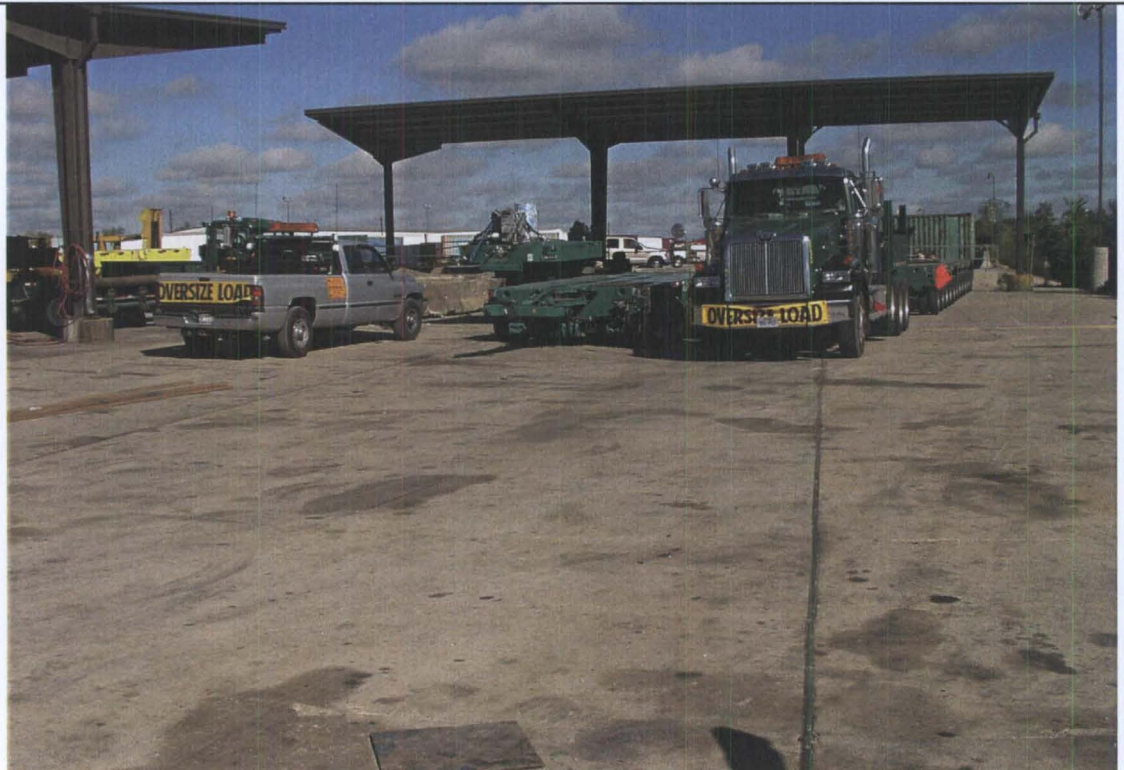
2

Photo shows basin 4 of southeast area concrete and joints.

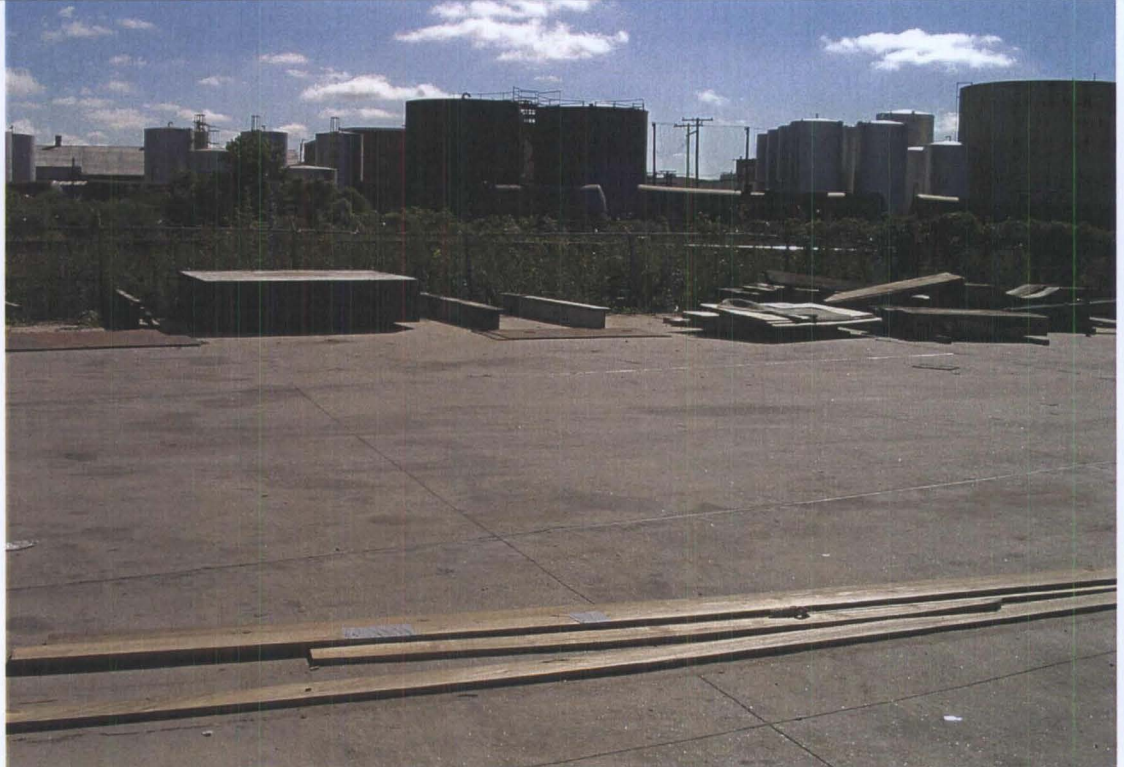
Photo No.
3

Basin 4 concrete cap and
joint. Photo also shows
typical use of cap in
southeast area.

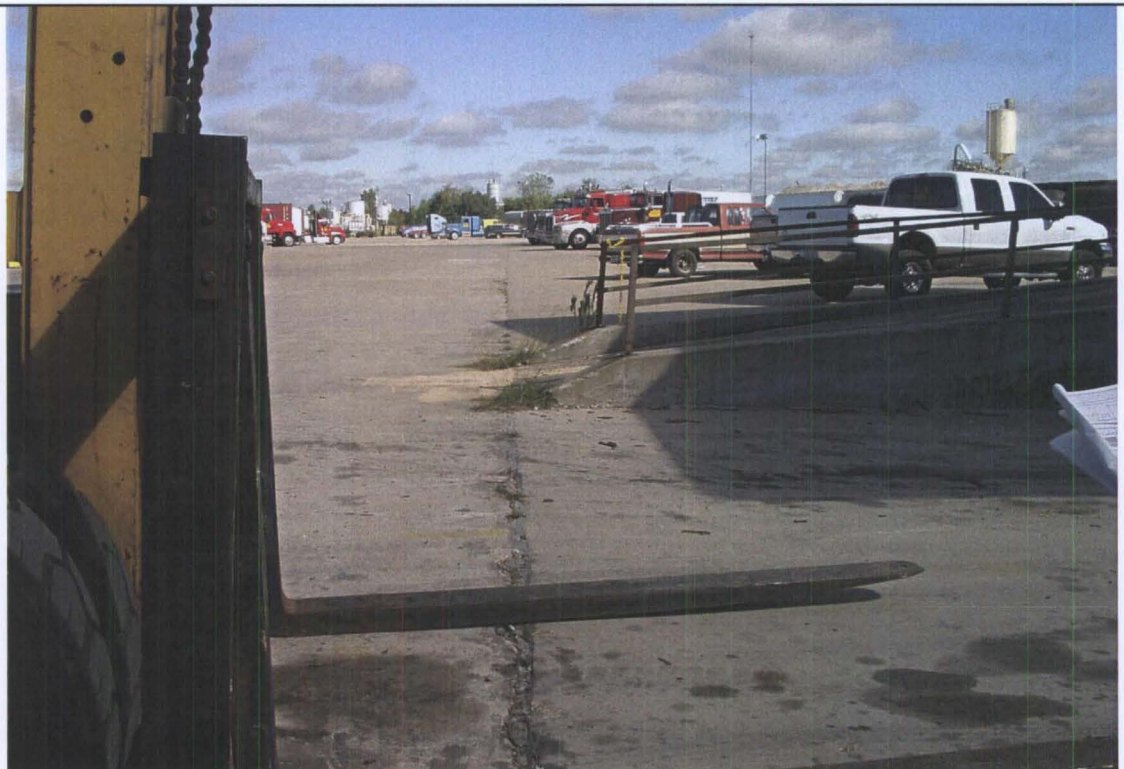
Photo No.
4

From basin 4 in southeast
area along existing
pavement and concrete
cap edge.

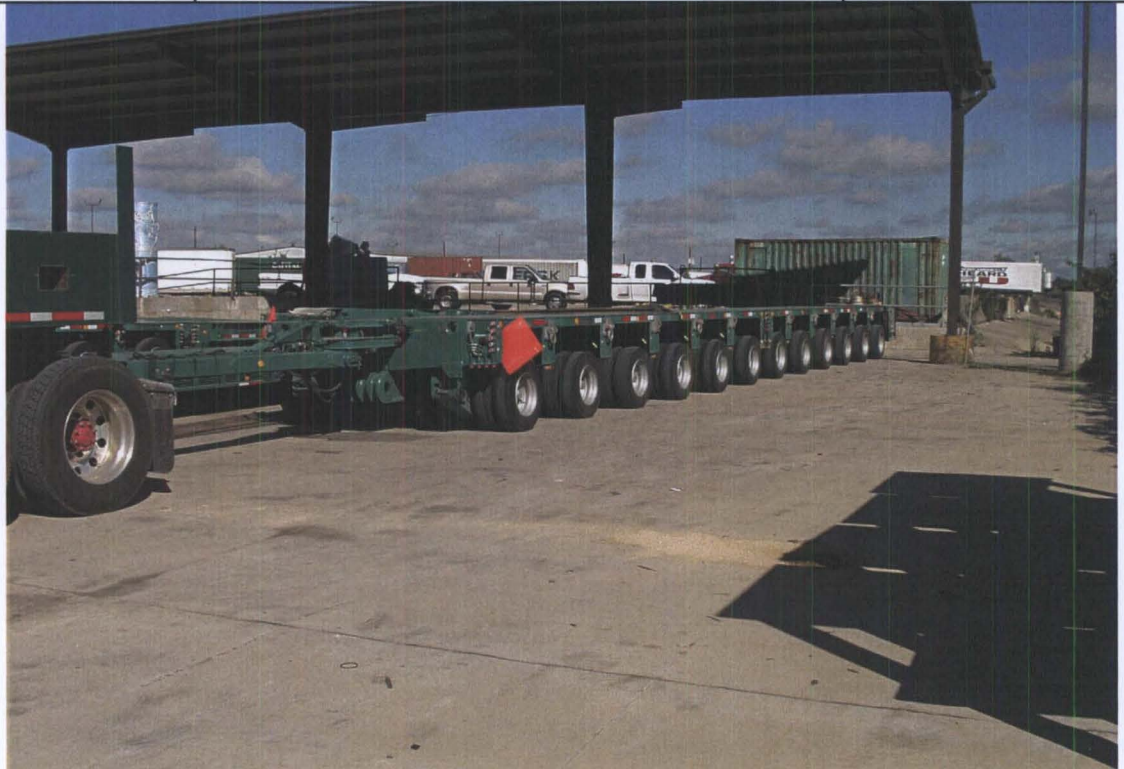
5

Near basin 4 and 3
interface along eastern
property line in southeast
area. Cap area shown is
being used for storage.

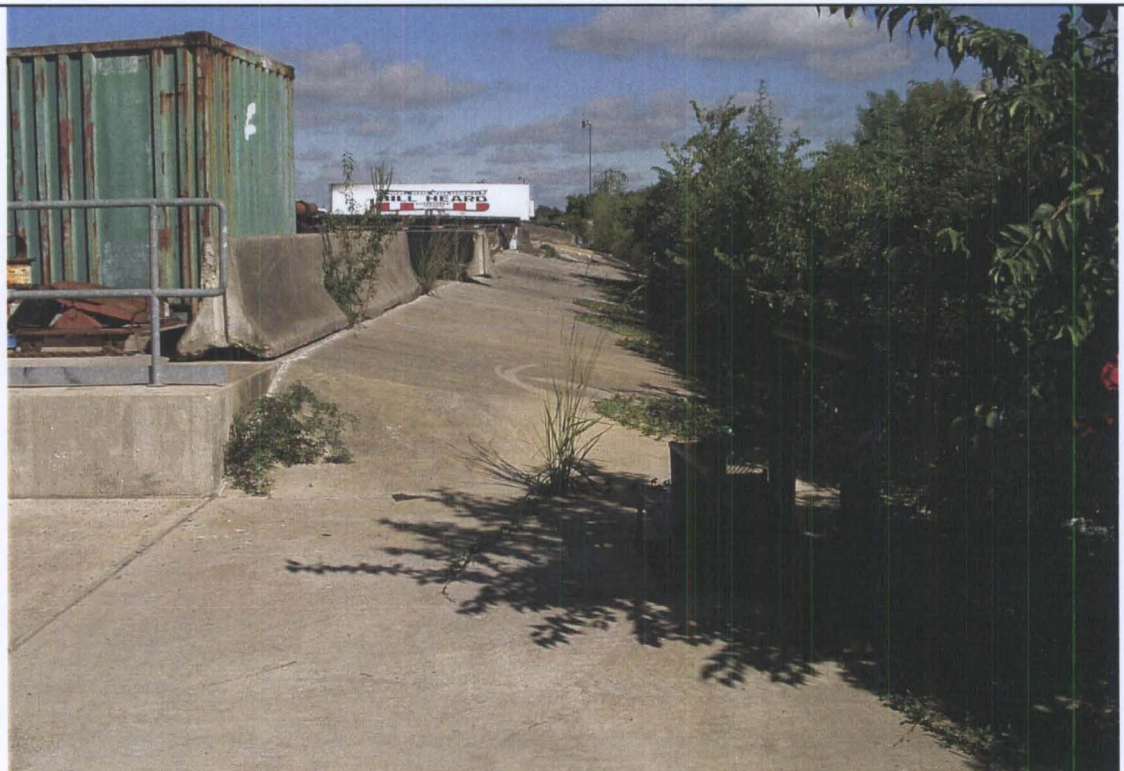
6

At basin 3 in southeast
area along slope
pavement near property
line. Concrete is in good
condition.

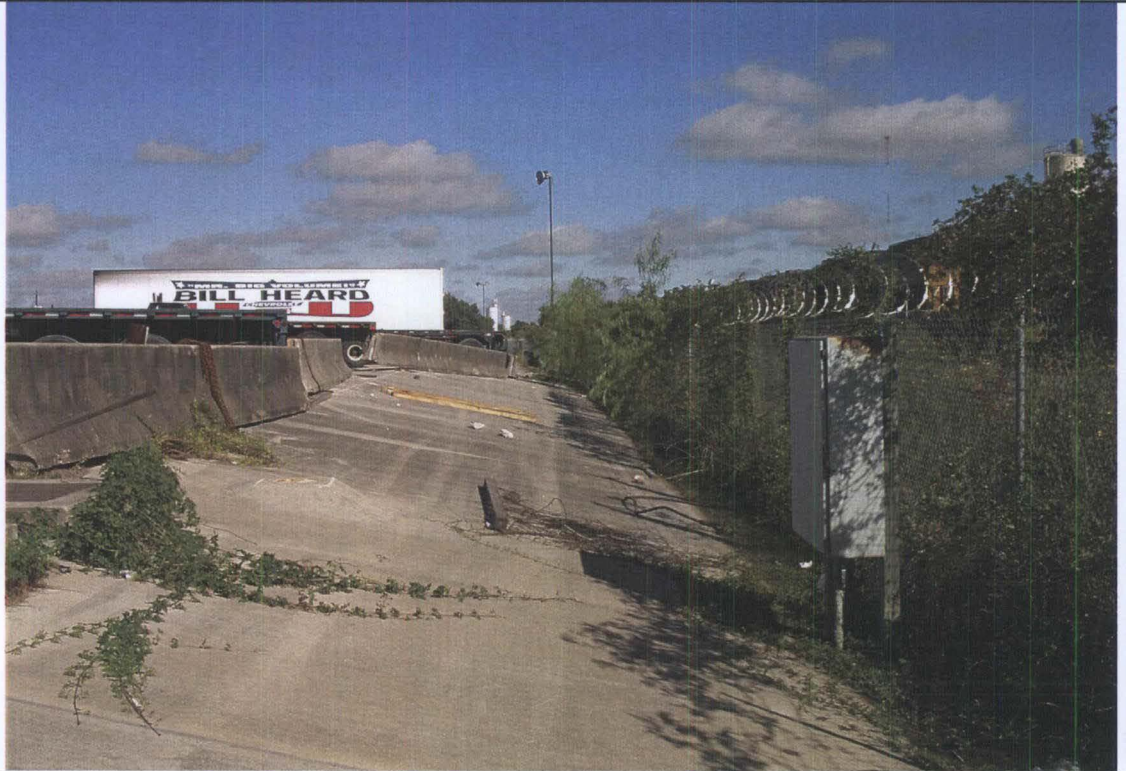
7

Photo taken along slope
pavement in southeast
area at the existing utility
box location. On the left,
photo shows a location of
weed problem occurring
along the eastern joint.

- Repair joints where needed; and
- Remove weeds by use of spray, determine cause, and make necessary repairs.

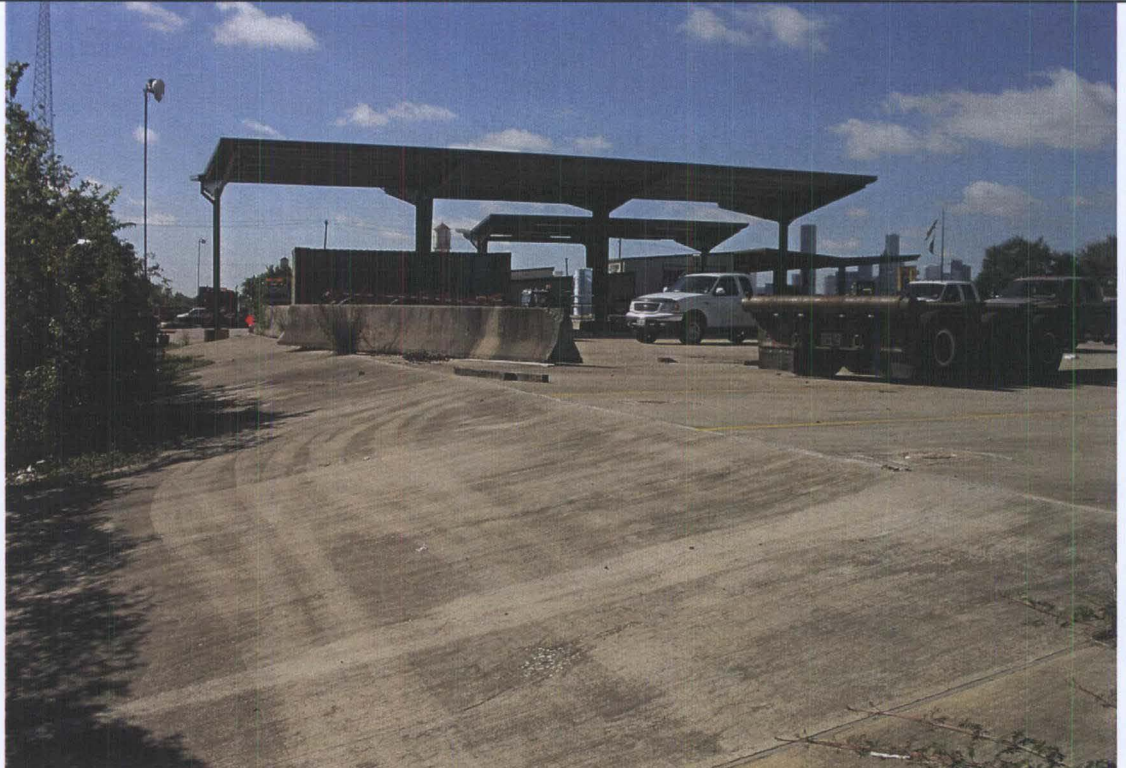
8

From basin 3 in southeast
area along property line.
Photo shows slope
paving.

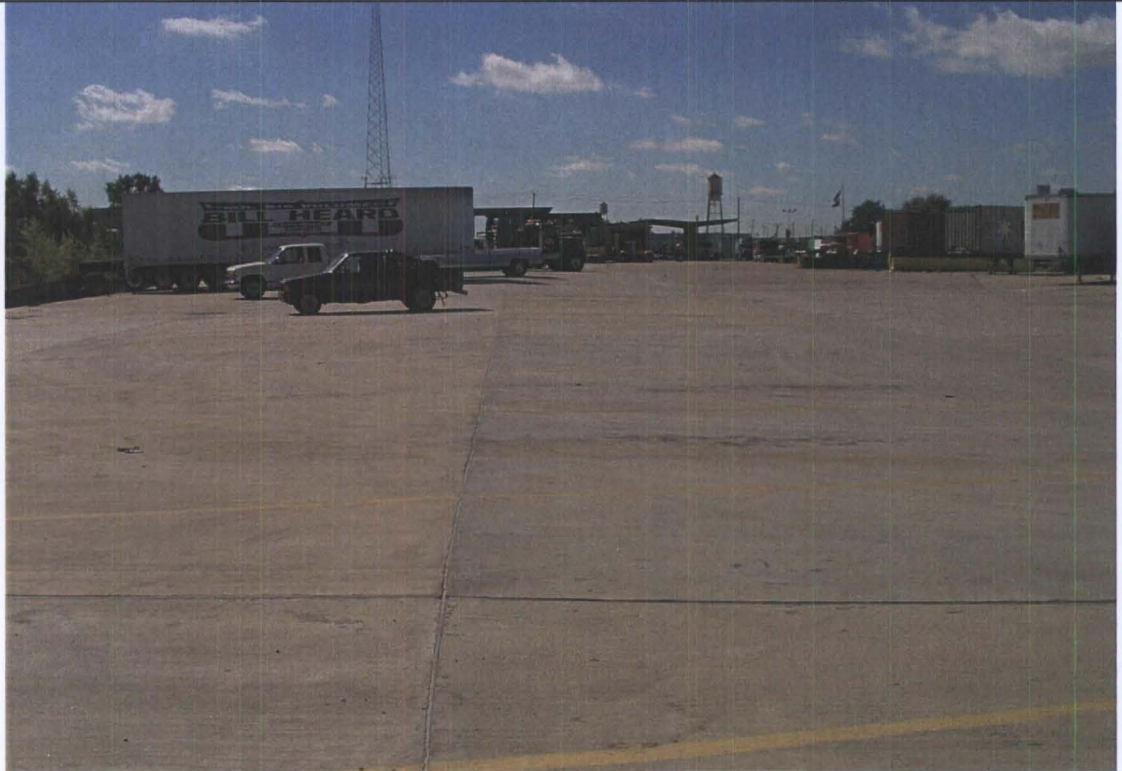
9

From basin 1 towards
basin 2 in southeast area
along the edge of existing
pavement and concrete
cap.

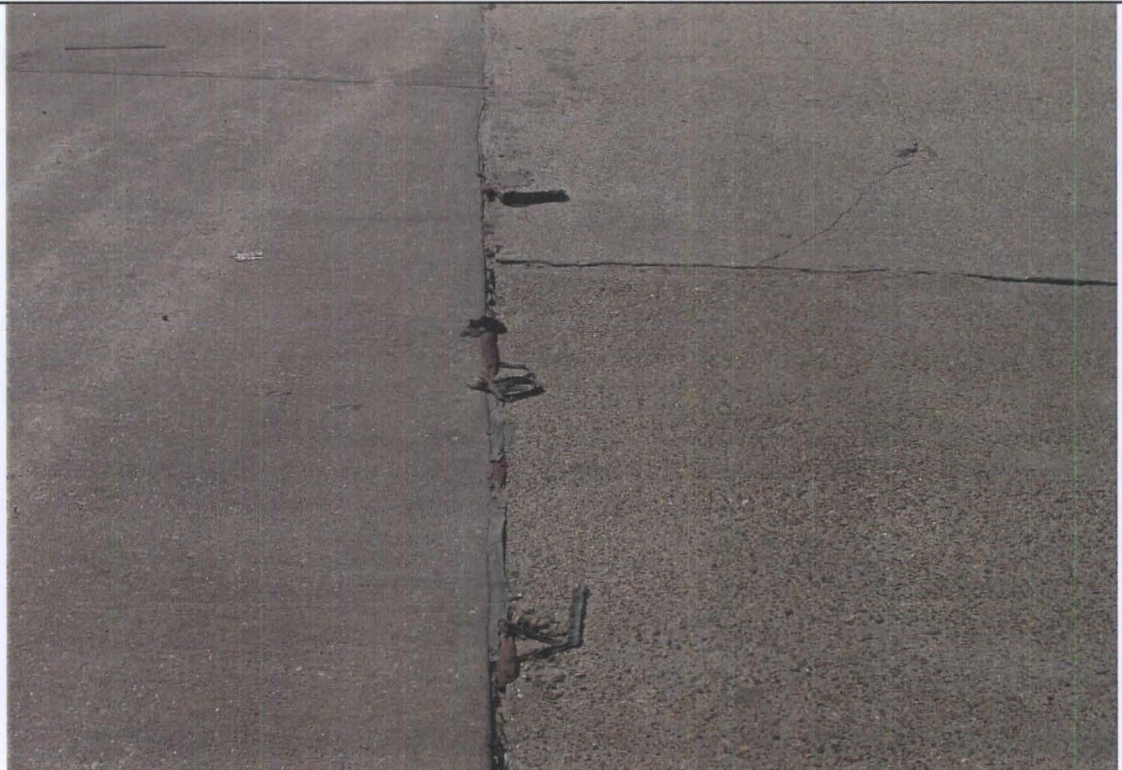
10

Based on the results of the property owner and site inspection, limited additional maintenance should be performed at the site. A few joints in the southeast area have become dislodged along the west edge of the cap. It was evident that additional joint sealant material had been placed through the cap, but locations were identified which continued to need repair. The southeast area also has some minor weed growth occurring along the eastern joint before the slope pavement and along the property boundary. It is recommended to remove the weeds, by using appropriate weed removal spray, and to determine if the joint needs to be repaired. These minor maintenance issues will not affect the performance of the design remedy with respect to its ability to provide the protection specified by the ROD. By copy of this letter report, the appropriate property owners are notified of the maintenance issues listed.

Photo shows joint
between concrete cap and
previously existing
concrete pavement in
southeast area. The joint
material has detached and
come out of the joint.

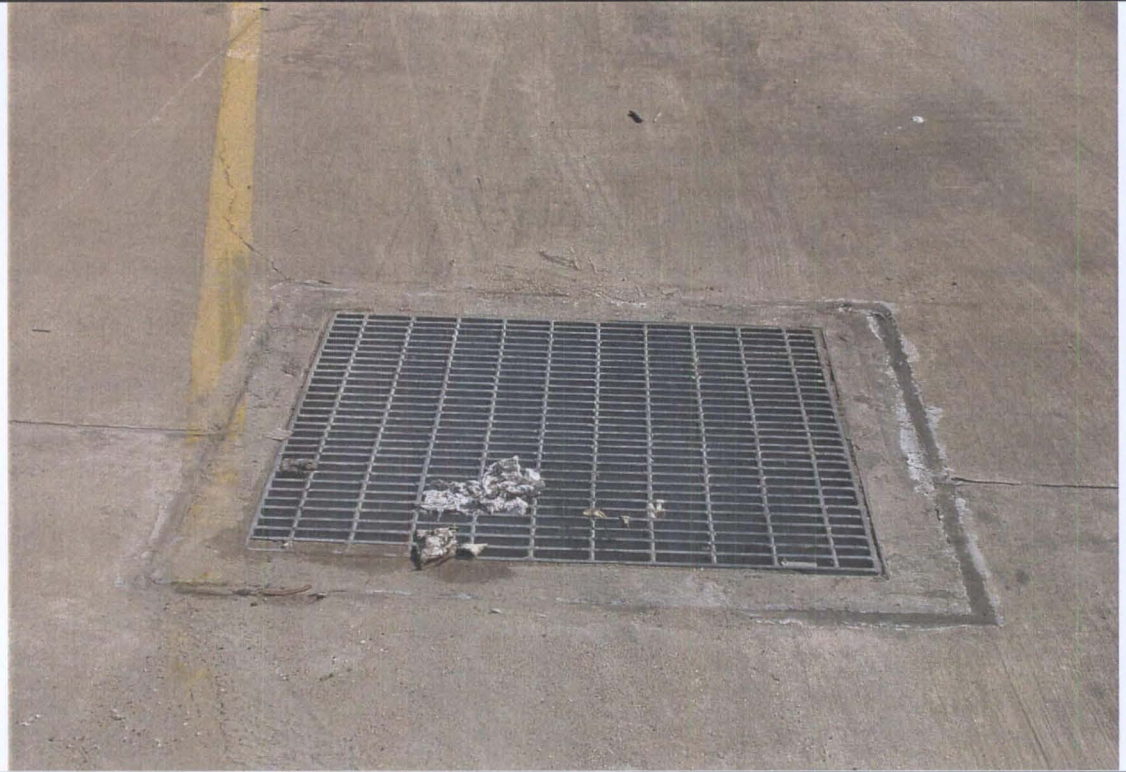
Photo No.
11

Photo shows typical
condition of stormwater
inlets and concrete joint
material surrounding
inlets.

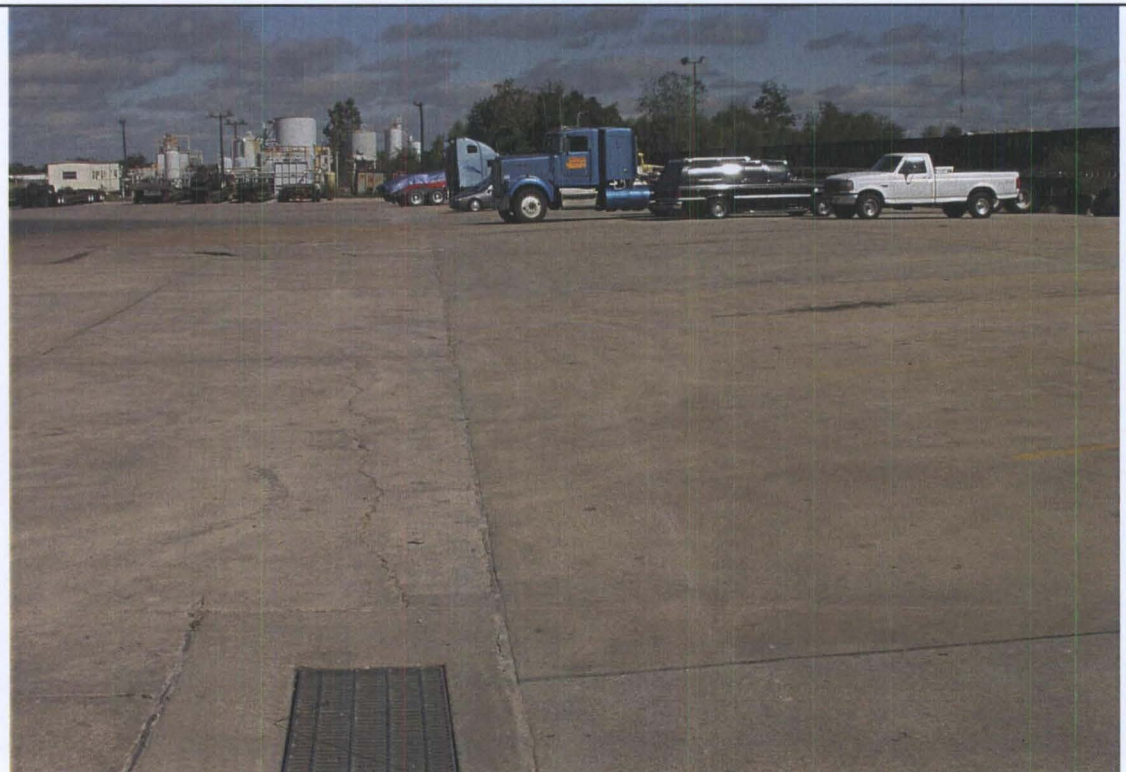
Photo No.
12

From basin 2 towards
basin 1. In southeast area.
Photo shows stormwater
inlet and condition of
concrete cap (to the right).

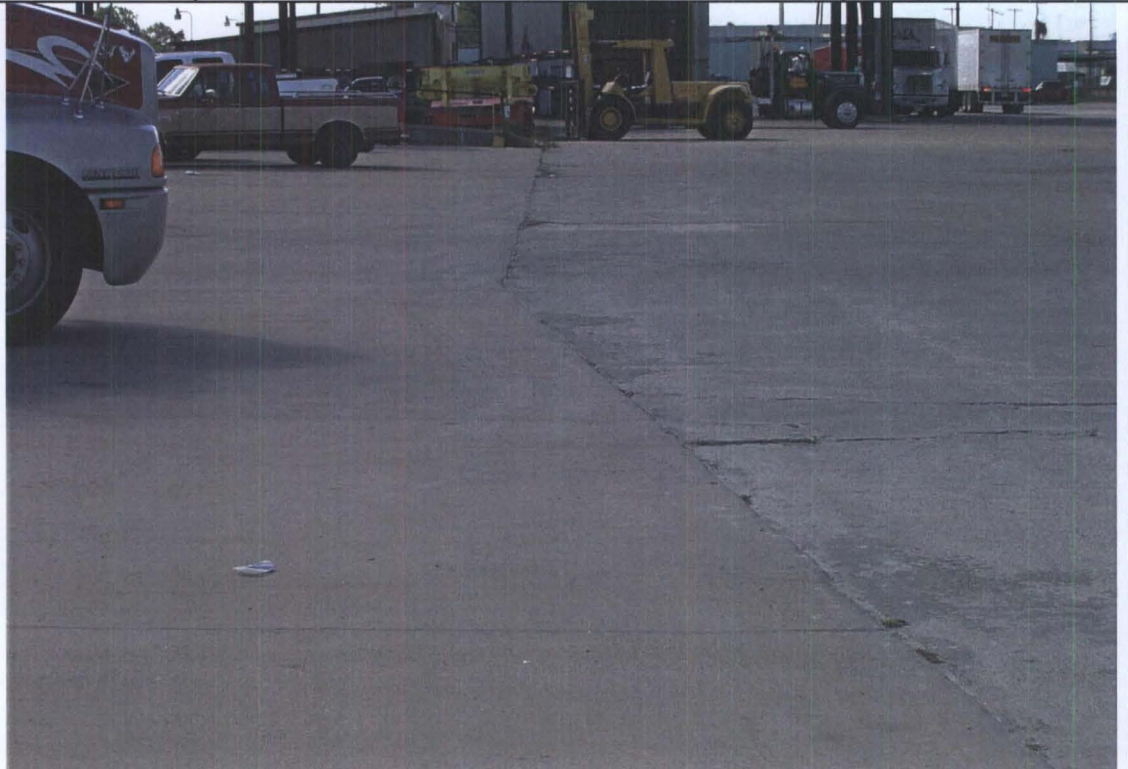
13

From basin 3 towards
basin 4 in southeast area.
Photo shows concrete cap
and joint.

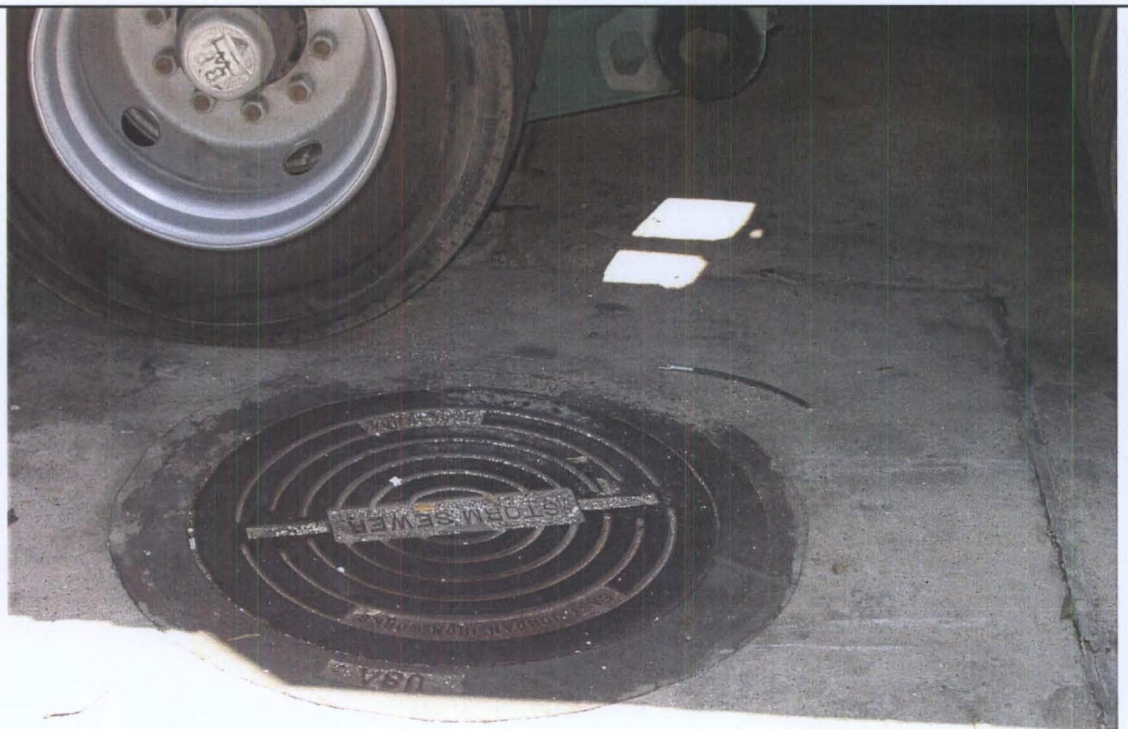
14

Photo shows typical
condition of manholes in
southeast area.

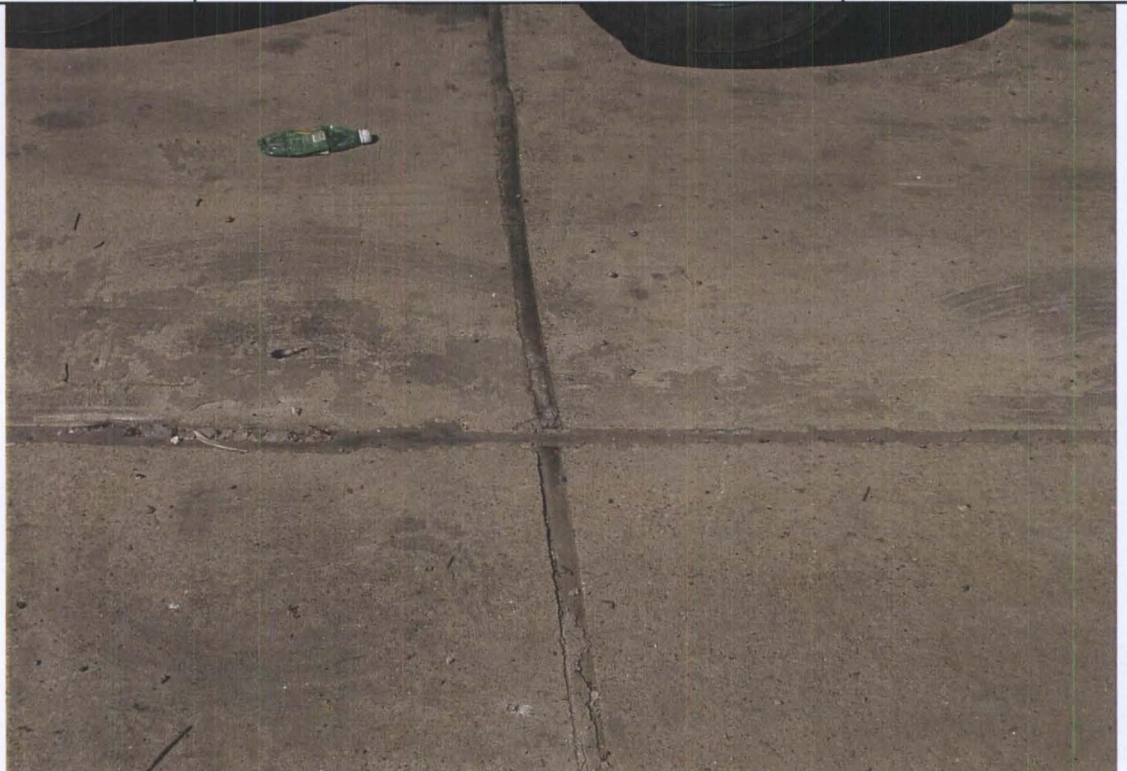
Photo No.
15

Photo shows typical joints
of concrete cap. Some
minor spalling has
occurred at joints.
Spalling pattern is typical
of concrete construction.

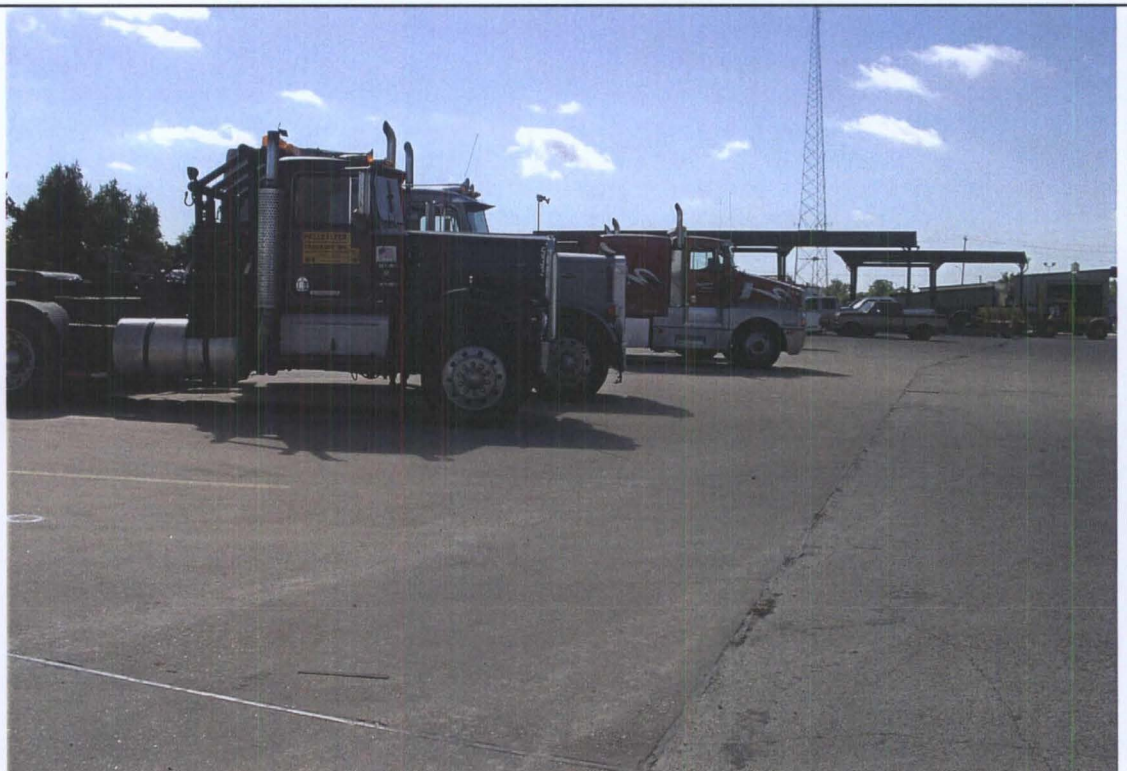
Photo No.
16

Photo taken along existing
pavement edge with
concrete cap. Typical use
of cap in southeast area
for parking is shown.

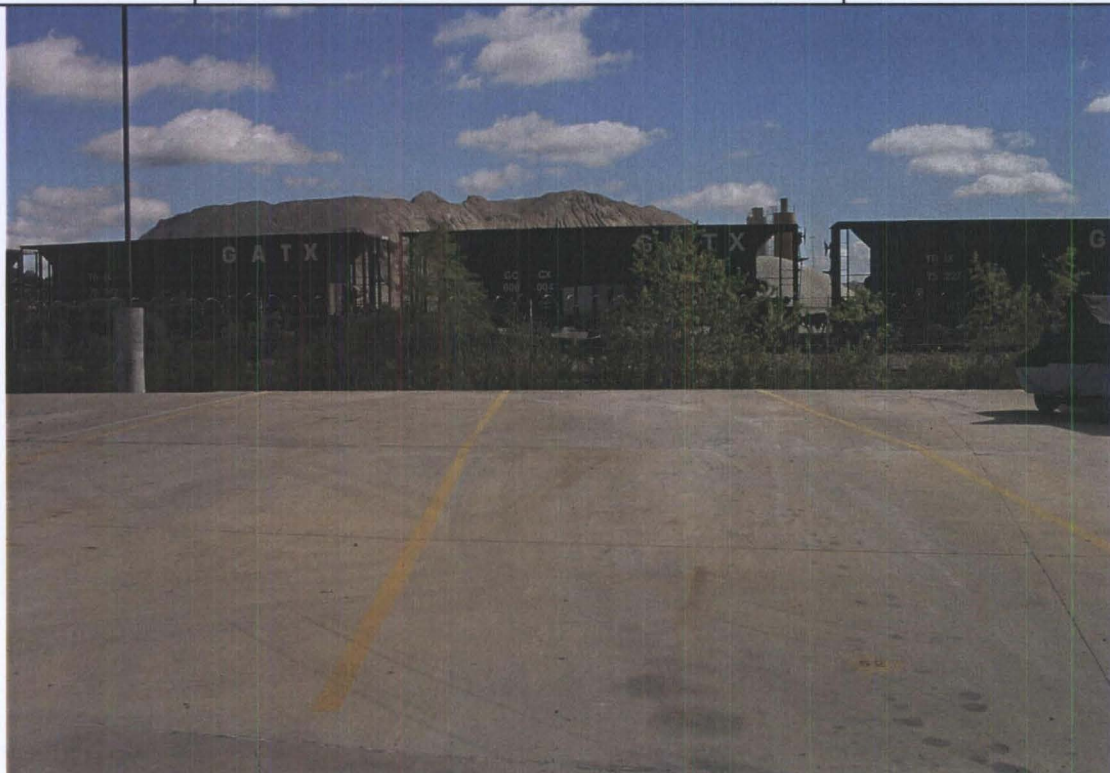
Photo No.
17

Shows concrete cap in southeast area. Photo is taken from the northern end of Basin 1.

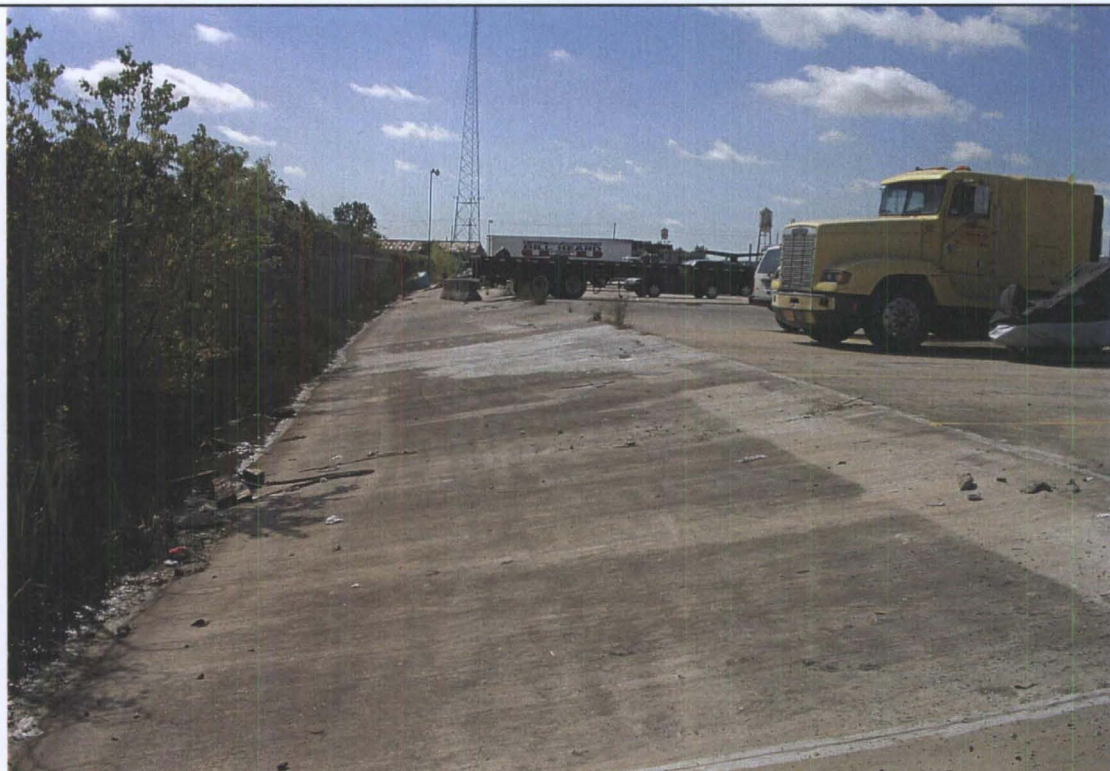
Photo No.
18

Photo shows slope pavement that connects to concrete cap at the northern end of concrete cap in the southeast area (Basin 1).

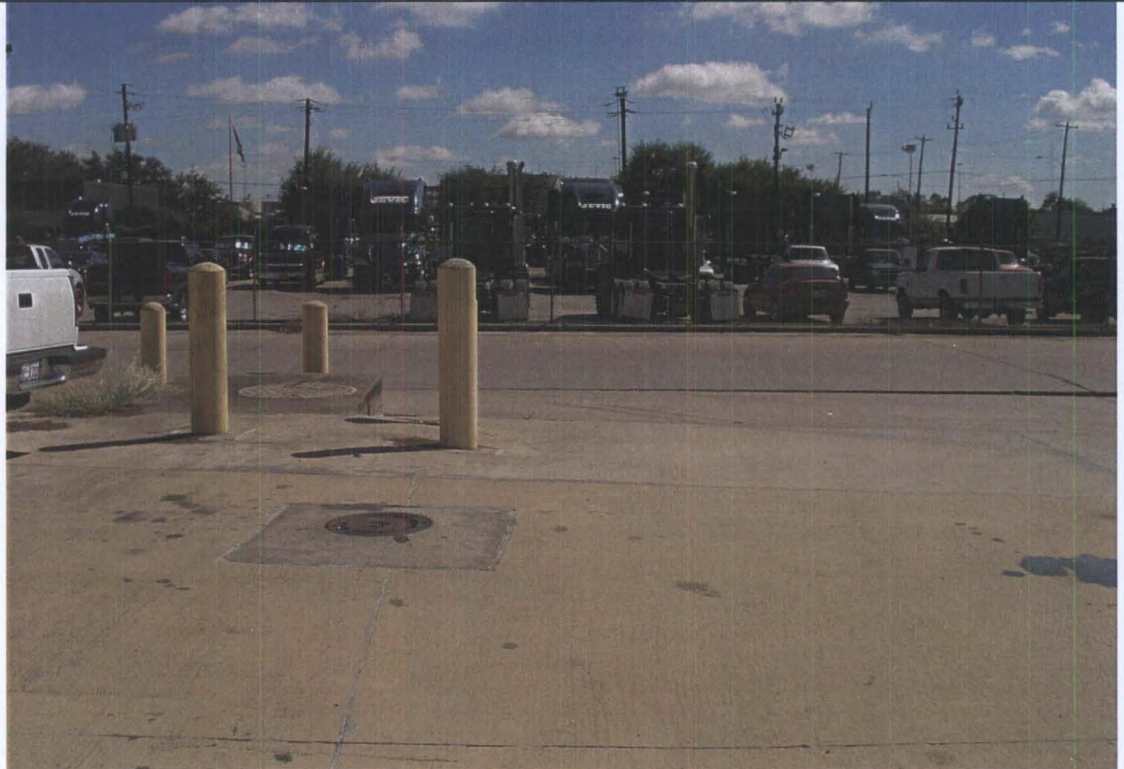
19

Photo taken on the
concrete cap in the
southwest area. Photo
shows protective bollards
in the northeast corner of
cap.

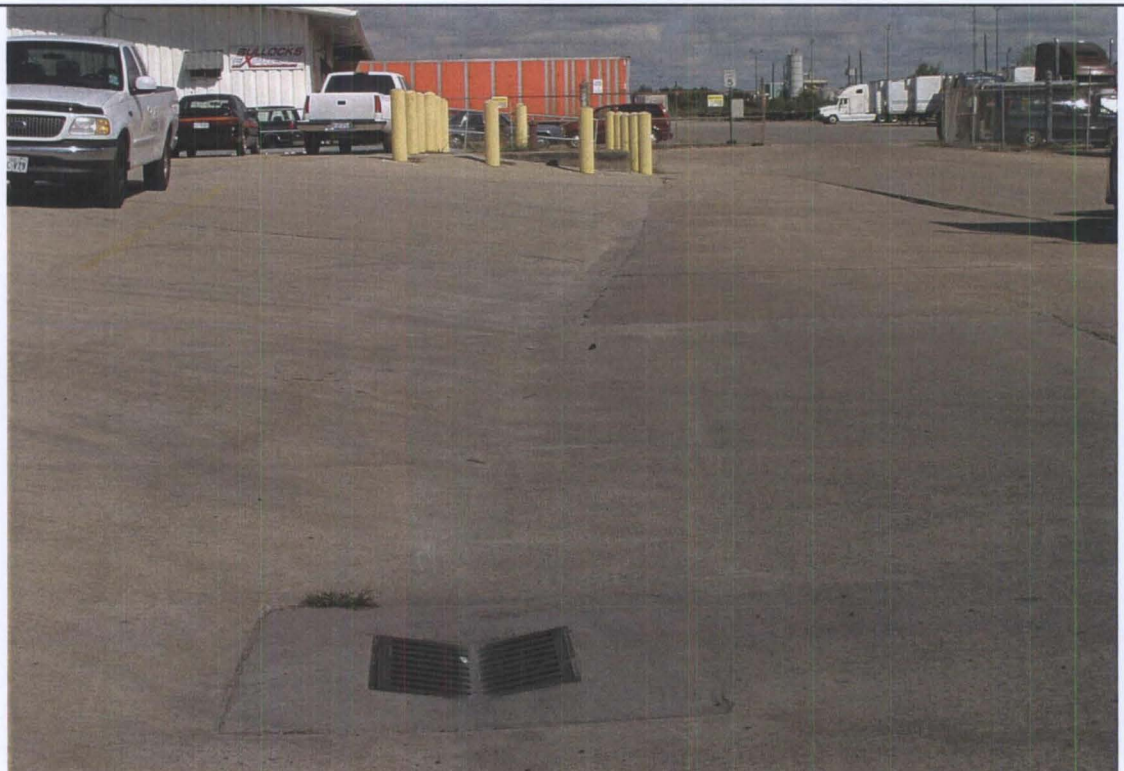
20

Photo taken in southwest
area shows stormwater
inlet.

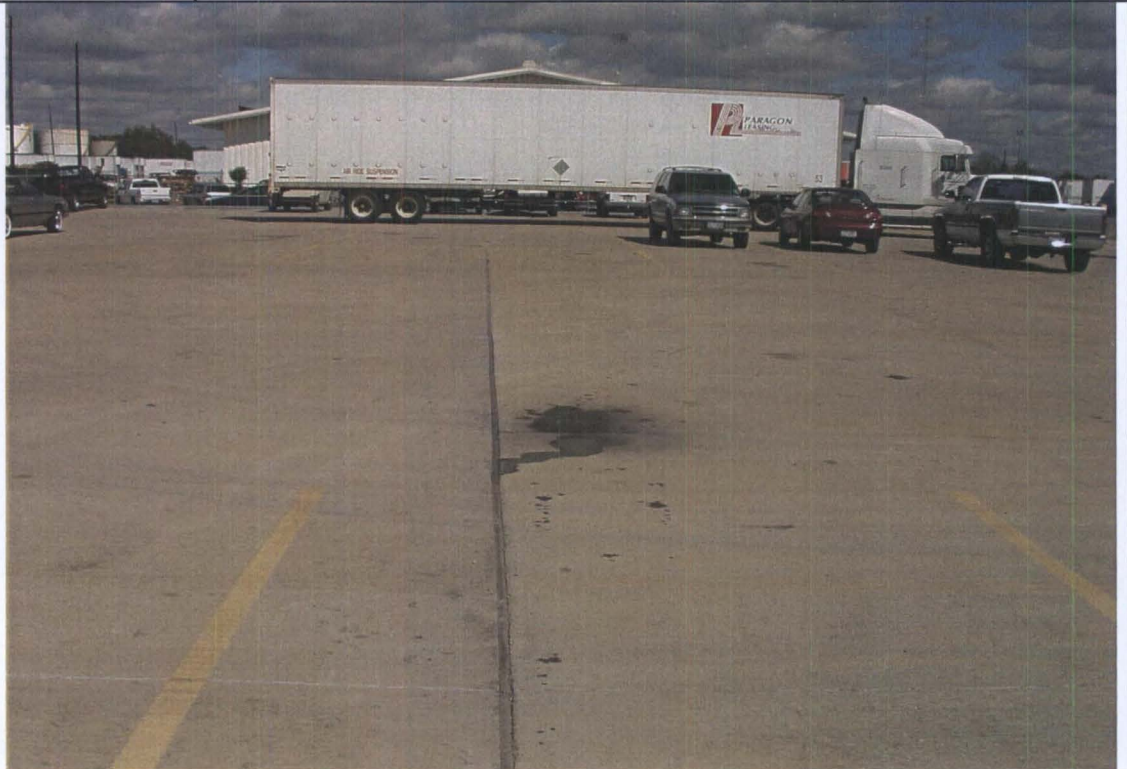
21

Photo taken along the
southern edge of concrete
cap in the southwest area.
Joint is in good condition.

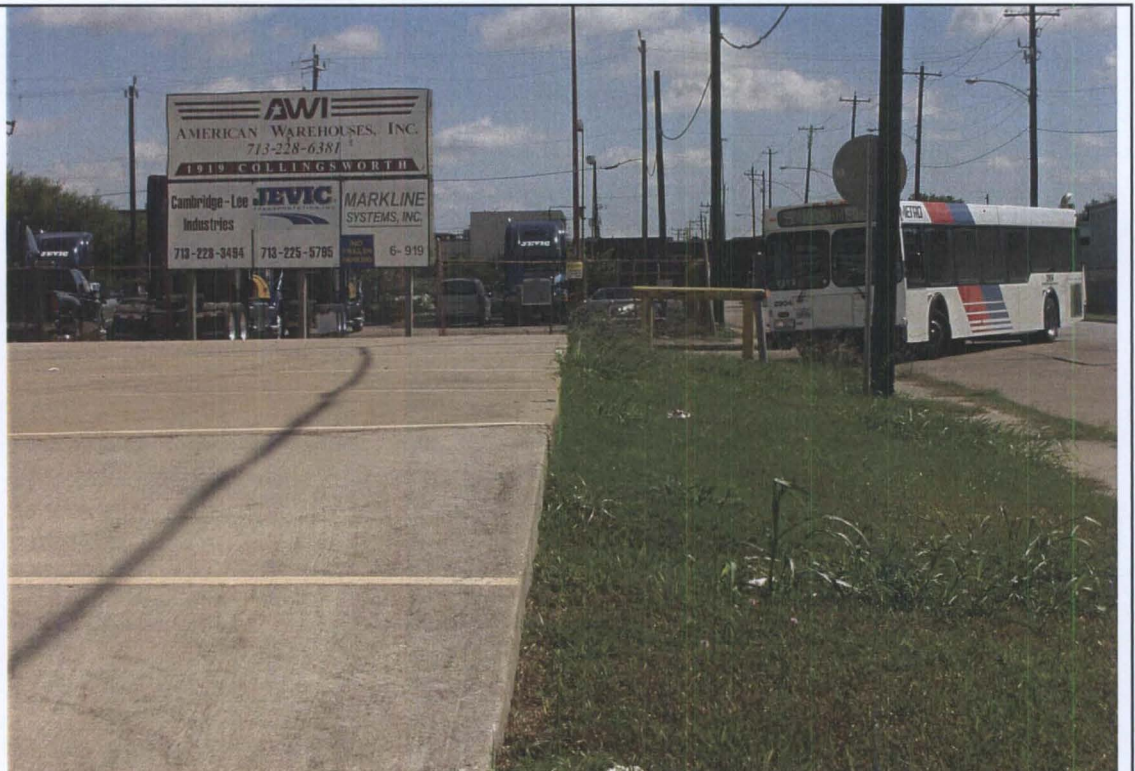
22

Photo taken along the
southern edge of concrete
cap in the southwest area.

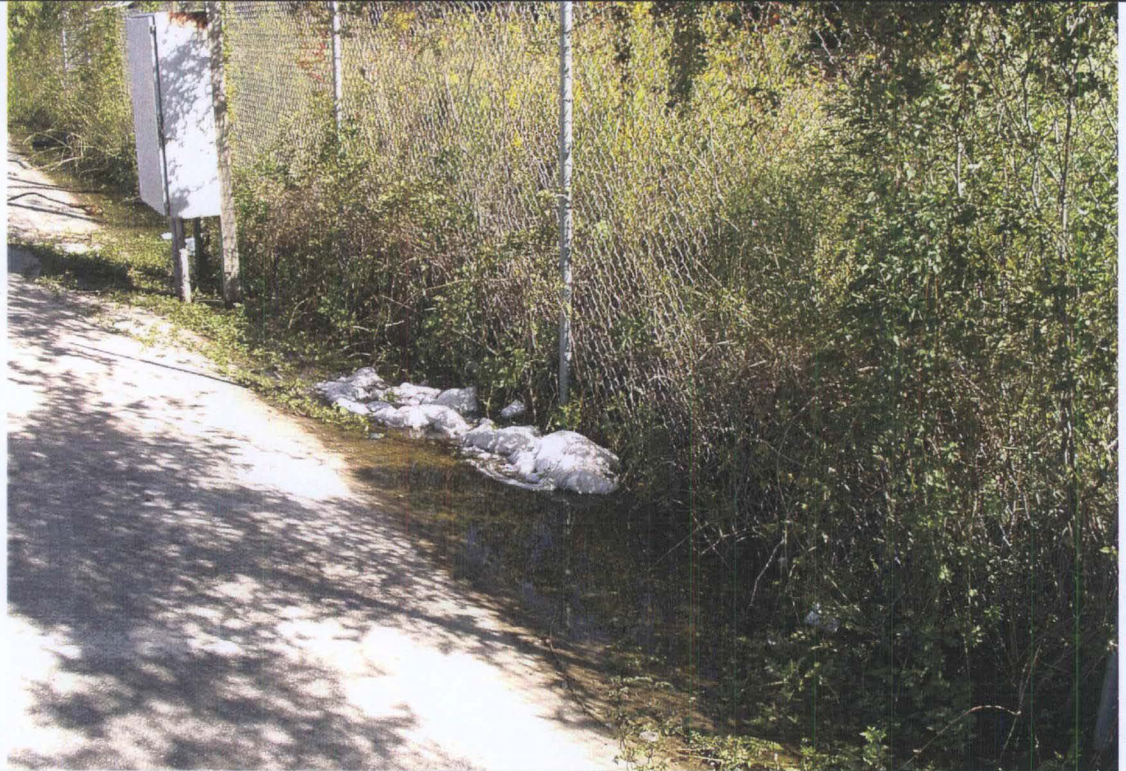
23

Photo taken along slope
pavement in southeast
area at the existing utility
box location. Photo
shows ponding water
along eastern property
line. Photo also shows
additional location of weed
problem.
